Minnesota State Capitol Preservation Commission Meeting

**Minnesota State Capitol
Restoration Project**

Water Intrusion and Settlement – \$17.261 million

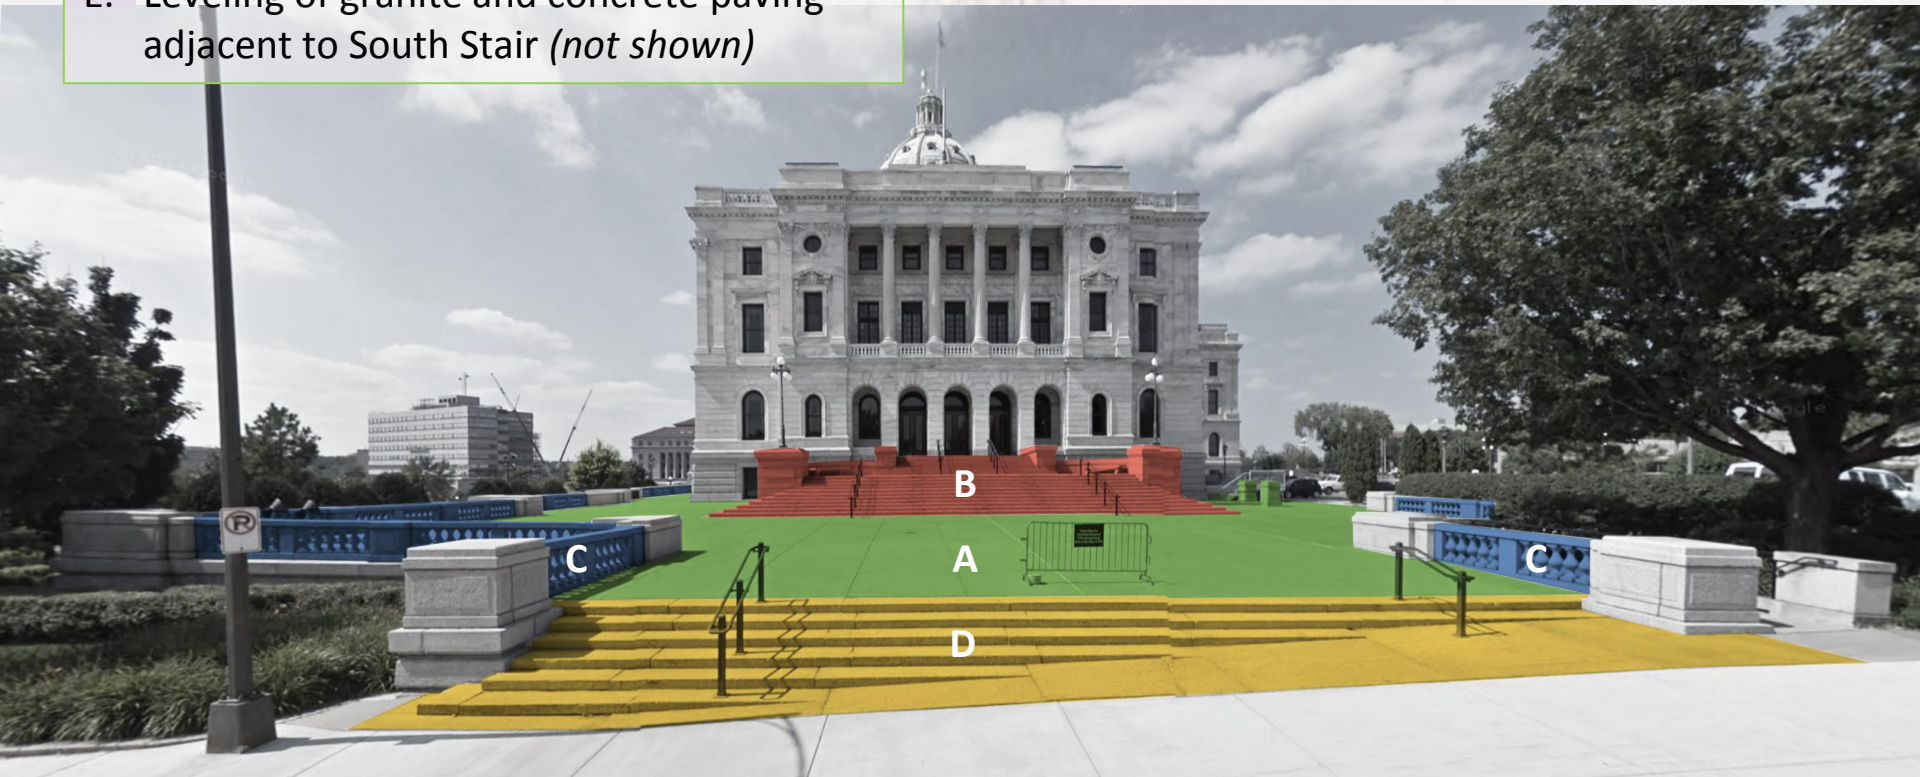
Scope of Recommended Repairs

Work Scope Key

- A. Terrace re-waterproofing
- B. Reconstruction of East and West Entrance Stairs
- C. Select Terrace balustrade reconstruction
- D. Reconstruction of East Stair (on grade)
- E. Leveling of granite and concrete paving adjacent to South Stair (*not shown*)

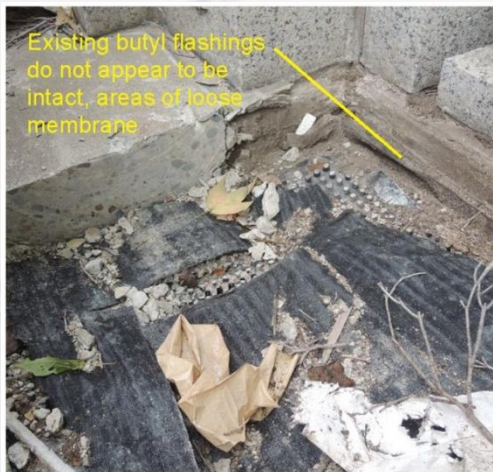
Selective Demolition of Concrete Wear Slab

- **Replacement Terrace Waterproofing System (existing is primarily bentonite and butyl system)**
 - Remove existing concrete wear slab, rigid insulation, drainage composite, and waterproofing.
 - Existing plaza drain locations to remain (repair/replacement drain bodies as required).
 - Install new hot fluid-applied waterproofing system, drainage composite, rigid insulation, and concrete wear slab.

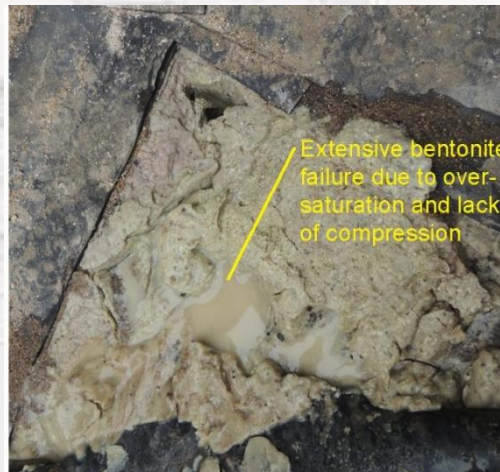
Selective Demolition of Concrete Wear Slab

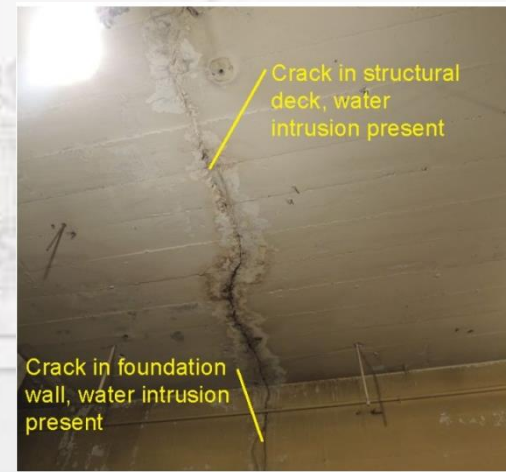
Interior View of Structural Slab at Basement East Wall

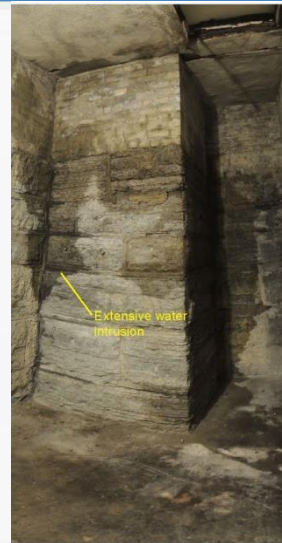
Interior View below East Entrance Stair

1. Remove existing granite treads, catalog, and store for re-installation
2. Demolish existing waterproofing over plywood deck over metal studs
3. Demolish top portion of existing masonry support (finger) walls, final depth TBD
4. Install new composite concrete deck
5. Install new concrete curbs for granite tread support
6. Install new plaza drains (connect to existing piping)
7. Install new waterproofing, drainage composite, and rigid insulation
8. Re-install existing granite treads on shims and grout
9. Install new sealant at all exterior stone joints

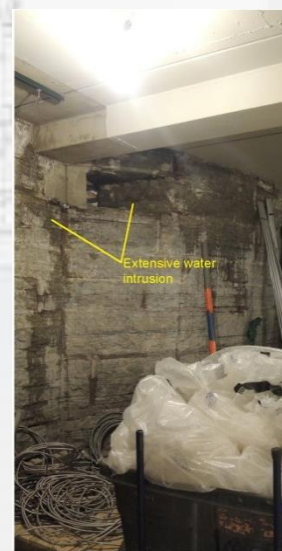
Interior View below West Entrance Stair

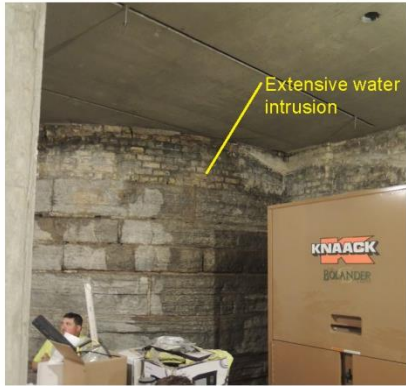
Interior View below East Entrance Stone Curved Wall

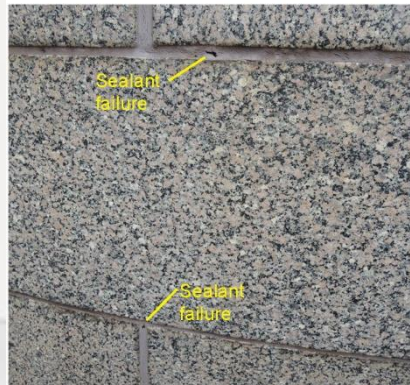
Sealant Detail at East Entrance Stone Curved Wall

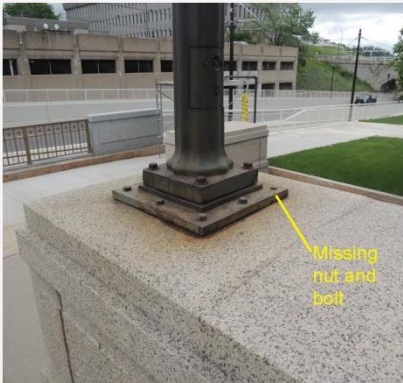
North Stair Light Pole

1. Remove light poles and bases (8 total).
2. Clean and prepare light pole assemblies in shop for new high performance paint. Provide new high performance paint in shop.
3. Re-lamp fixtures with new LED lighting.
4. Repair corroded or missing bolts and nuts for re-installation.
5. Seal conduit penetration through stone cap.
6. Reinstall light pole assemblies, set light pole bases in grout bed, with perimeter sealant at base.

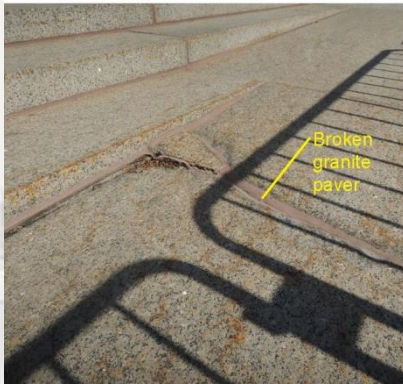
Granite Paving Settlement at East Stair

1. Allow vehicular parking to occur at areas adjacent to the South Stair.
2. Remove existing paving, salvage granite for re-installation.
3. Engineer soils to accommodate vehicular loads.
4. Reinstall granite paving, install new concrete paving.

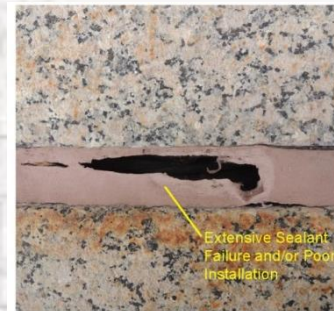
Sealant Detail at East Entrance Stair

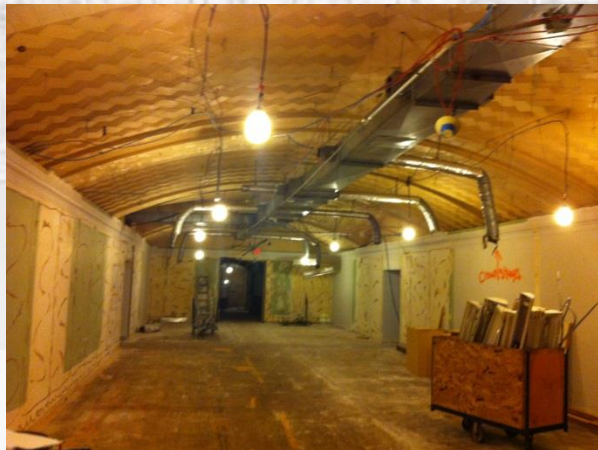
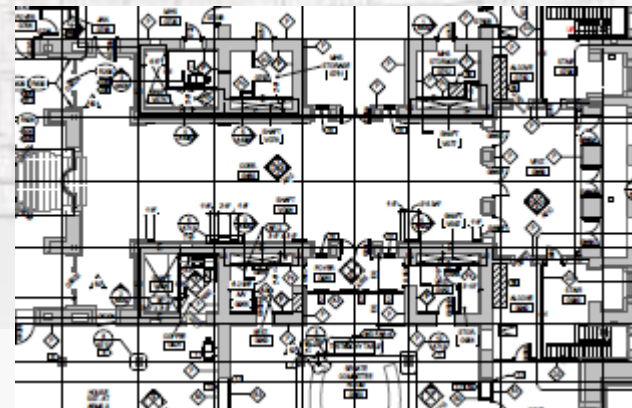
East Wing, Great Hall Stone Floor - \$257,000

- Original historic flooring was wood on sleepers.
- Previous project removed wood flooring and installed carpet on a concrete topping level with adjacent stone

- Remove concrete topping and install a new stone floor level with adjacent stone flooring

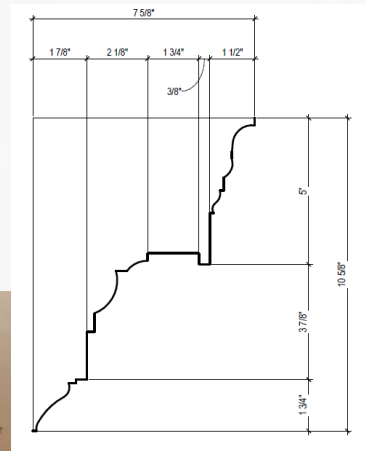
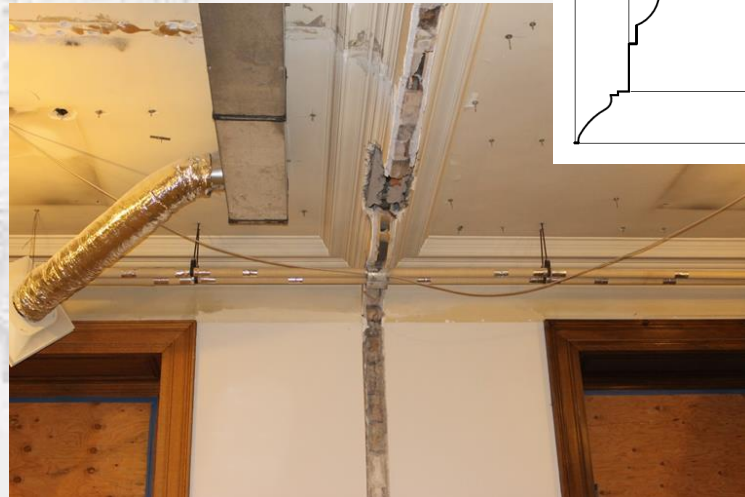
Cove Molding - \$150,000

- Demolition uncovered badly damaged existing plaster crown moldings in many first floor spaces.

- Maximize ceiling height with HVAC and sprinkler piping concealed above new gypsum board ceilings
- Install new glass fiber reinforced gypsum (GFR) moldings in similar profile to the original plaster moldings.
